Manhole Inspection Summary

Manhole # S3100_006MH

Insp Date: **4/25/07 9:18 AM**

Location Address: **2400 24TH ST**

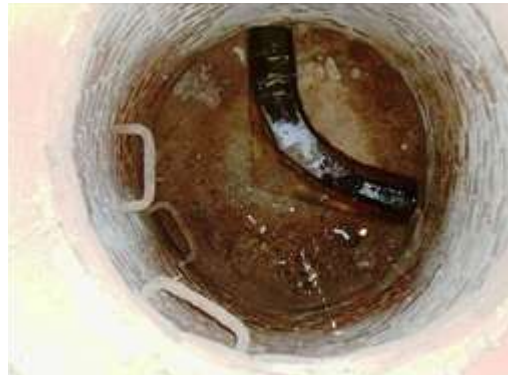
Top View

Bench ☒ Exists Material: **Brick** ☐ Parged ☒ **Debris** (not Condition related)
Condition: ☒ Sound ☐ Cracked ☐ Root Intrusion ☐ Deteriorated ☐ Leaks ☐ Debris

Steps Count: **3** Missing: **0** ☒ **Corroded**

Surcharge ☒ **Evidence Of Surcharge** Depth: **1** (ft.) ☐ Active Surcharge Present

Corroded steps. Evidence of surcharge - Bench debris.

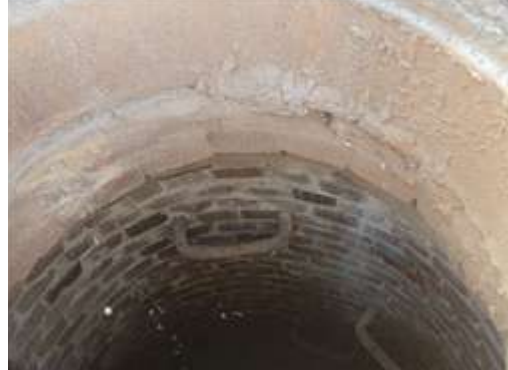
Defect

Frame Offset: **0.5** (in.) Condition: ☐ Sound ☐ Cracked ☒ **Leaks**

Chimney / Frame Adjustment ☒ Exists Material: **Brick** ☐ Parged Height: **6** (in.)
Condition: ☐ Sound ☐ Cracked ☐ Root Intrusion ☐ Loose Brick ☒ **Deteriorated**
Infiltration: ☐ None ☒ **Joint** ☐ Cracks ☒ **Mortar** ☐ Roots ☐ Wall

Frame leaks. Adjustment deterioration and infiltration - other side.

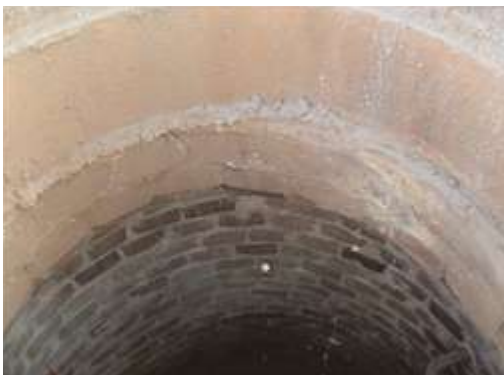
Defect

Frame leaks. Adjustment deterioration and infiltration.

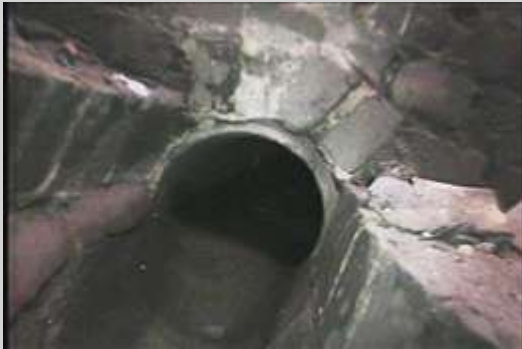
8 in. Circular Gravity Sewer Pipe Out @ 12 O'Clock

Barrel infiltration.

Deposits: ☐ None ☒ **Mud** ☐ Sludge ☒ **Debris** ☐ Grease

Infiltration: **Evidence** Pipe Seal Cond: **Unknown**
